Building Inspection Report

1234 Main St Ave Los Angeles CA, 90018

Inspection Date:
9-30-10

Inspector:
Julie T. Beller

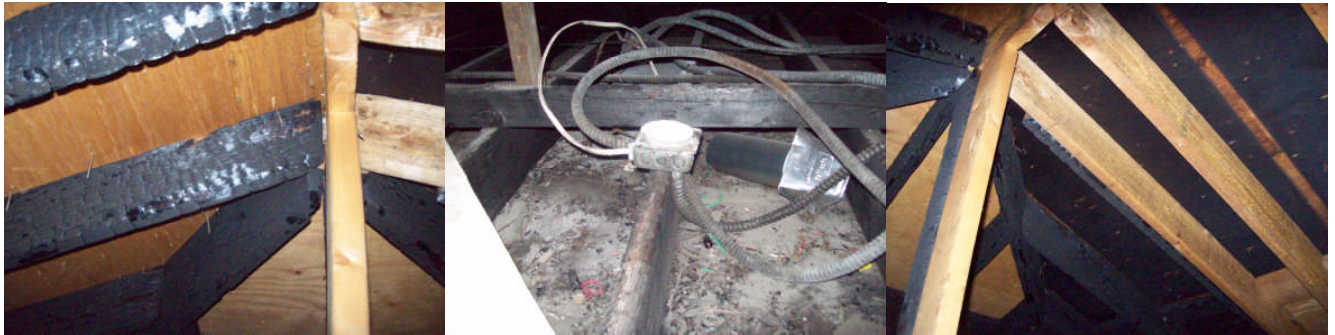
- **Improve:** The attic has had past fire damage. This charring has exceeded 10 percent. Some of the framing has been replaced. However other frame members appear to be in need of replacement. I recommend asking the seller for more information, checking permits for current repairs and checking public records regarding the past fire. Also aluminum paint is typically installed to prevent the fire damage from producing an odor. I recommend contacting a licensed contractor for further evaluation and correct as needed prior to close.

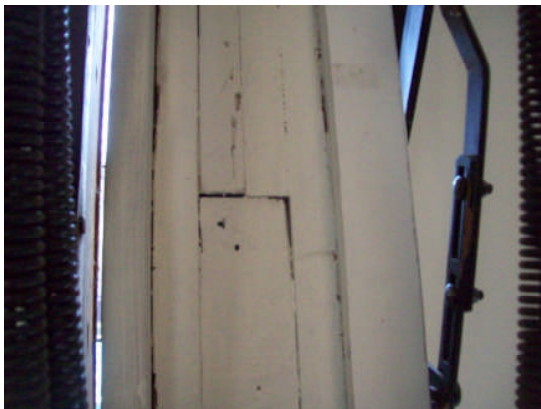
- **Repair:** The exterior wall structure /post for the garage on the west wall next to the doors has had a post that had been pieced together rather than have a solid framed post. I recommend contacting a licensed contractor for further evaluation and correct as needed.

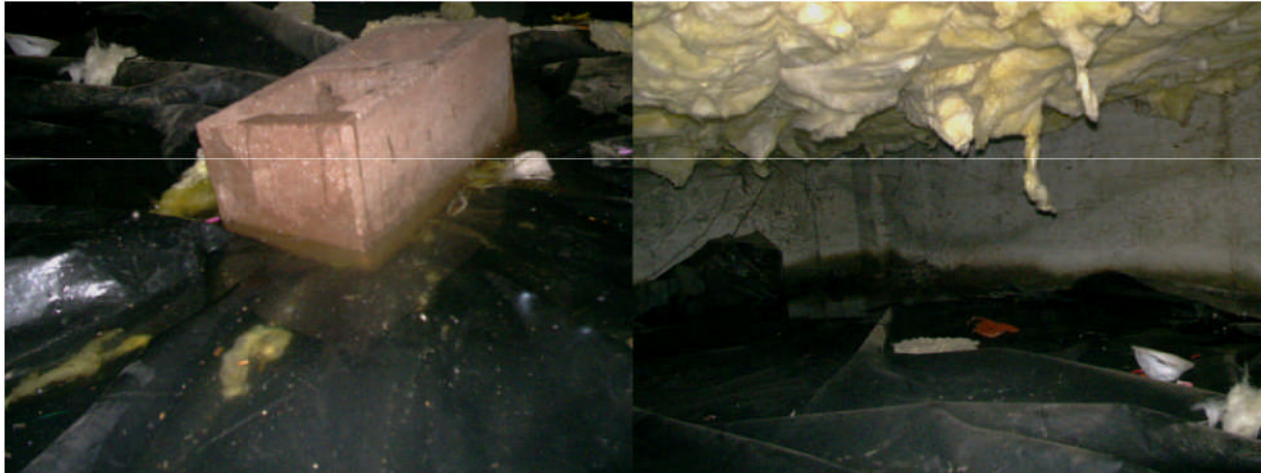
Improve: Standing water was observed in the crawl space on the east wall. Lot drainage improvements should be addressed as a first step to controlling water in the crawl space. This condition should then be further evaluated by a drainage contractor prior to close.

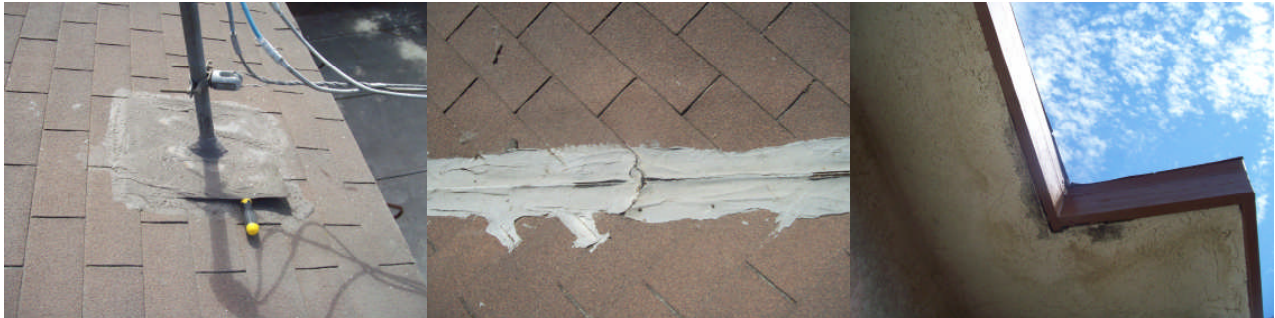
- **Repair:** The roofing has a patching material throughout the valleys on the flashing and in other areas of the roof. The craftsmanship appears substandard. Damaged shingles are present. Exposed nails were also visible. We recommend maintaining vegetation growth near the roof as needed to prevent damage to the roofing materials. Vegetation near or touching the roof surface. One of the vents is missing its cap. The utility boot for the electrical service entrance and mast on the NW side is lifting above the shingles. A licensed roofing contractor should further evaluate the roof and repair as needed prior to close.

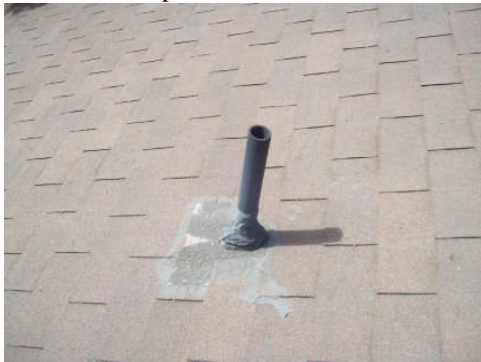
- **Improve:** Mastic is cracked/deteriorated on the roof. We recommend corrections as needed at this time to prevent leakage.
- **Improve:** ABS plastic vents are not protected from sun exposure. Exposed plastic piping is required to be painted or otherwise protected from deterioration by the ultra violet (UV) rays from the sun.

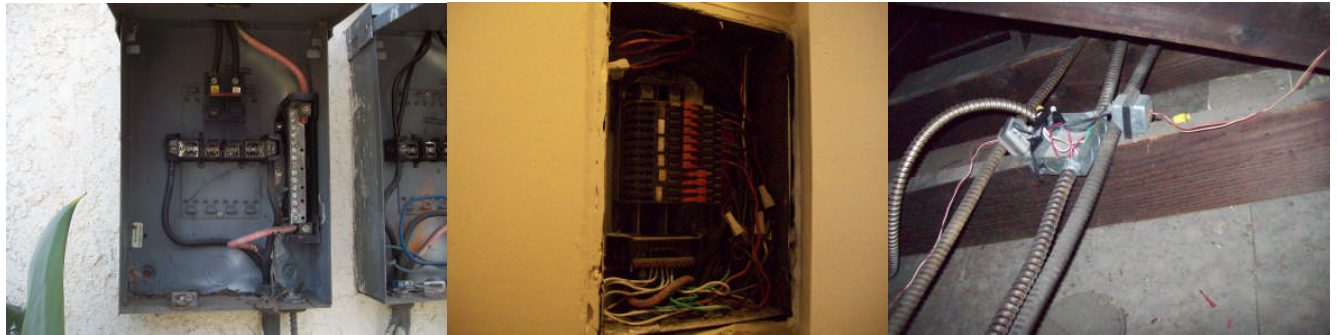
- **Major Concern: Safety Issue:** The exterior electrical shut offs, below the meters, at the back of the building are Federal Pacific Electric "Stab-Lok" service panels. These breakers are a latent hazard and the FPE circuit breakers can fail to trip in response to over current, leading to electrical fires. I recommended contacting a licensed electrician for further evaluation and correct as needed prior to close.

- **Major Concern: Safety Issue:** The panel in 3427 is a Zinsco and Zinsco-Sylvania circuit breakers do not offer the level of over current and fire protection provided by most other electrical panels and circuit breakers. Rusty screws and oxidation was found in this panel. The directory on the panel (describing the location of the breakers) is incomplete. I recommended contacting a licensed electrician for further evaluation and correct as needed prior to close.

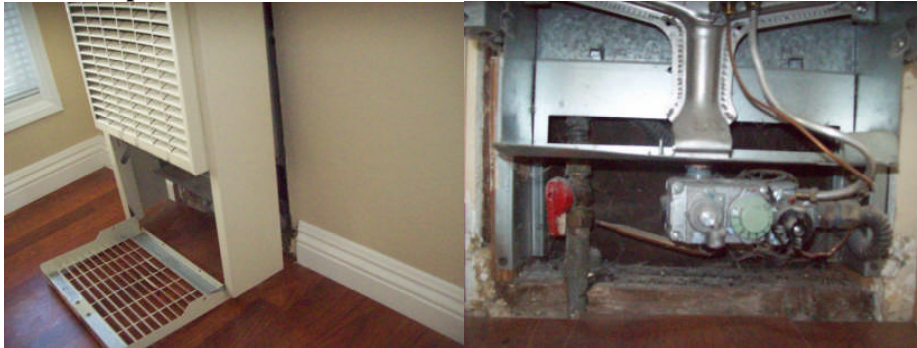
- **Improve:** The wall heater was off at the time of the inspection. Both heaters ideally should have fire separation between the lower portion of the unit and the laminate flooring. In unit 3429 the metal frame of the heater was loose to the wall. Contacting a heating technician for further evaluation and correction as needed is recommended prior to close.

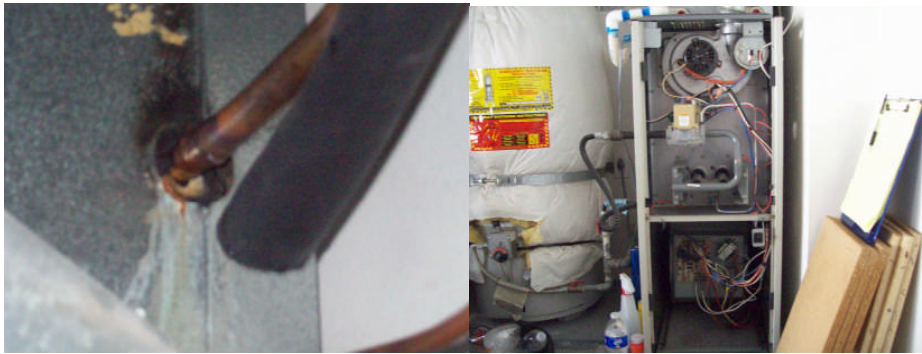
- **Improve:** Directly above the furnace is the evaporate coil and the refrigerant lines was dripping. A condensate tray should be added to prevent dripping into the furnace. The seal (tape) along the right side of the furnace has separated. A lot of condensation was dripping out of the exterior discharge tube. The air conditioning system may be low on Freon and requires further evaluation and repair, prior to close by an HVAC technician.
- **Improve:** The compressor label stated that the breaker at the electrical panel should not exceed 30 Amps and the breaker is 40 Amps. Contact a licensed electrician for further evaluation and correct as needed.

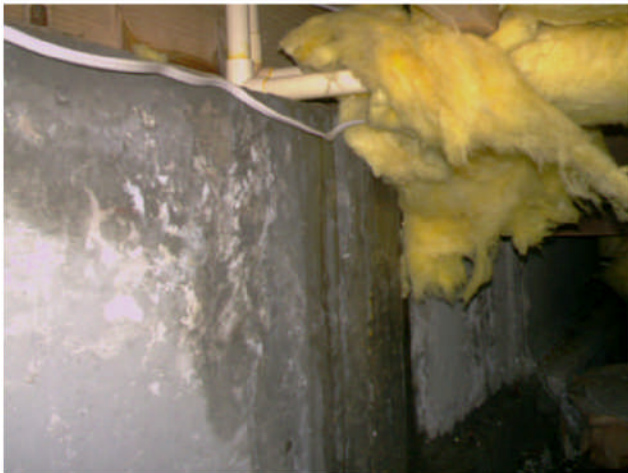
- **Improve:** Disconnected plumbing was visible at the north wall of the crawl space. This was causing the south garage wall to be wet. Also mold was found in the sheetrock on the garage wall that should be replaced. I recommended further evaluation and correct as needed prior to close by a qualified licensed contractor.
