Building Inspection Report

1234 Main St Ave Los Angeles CA, 90018

Inspection Date:
9-30-10

Inspector:
Julie T. Beller

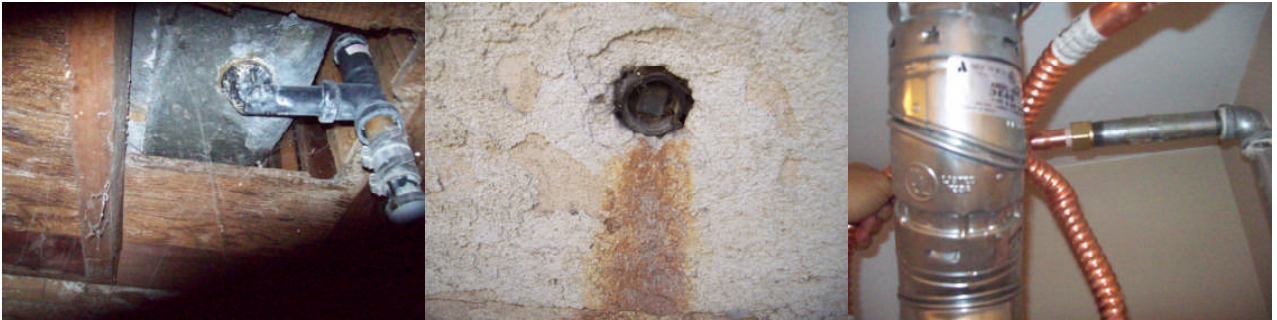
PLUMBING OBSERVATIONS

- **The gas supply to the house was shut off.**

- **Improve:** No sediment trap on the gas line for the water heater or furnace. Sediment traps protect the appliance from malfunctioning due to debris in the gas line. We recommend sediment traps at all gas water heaters.
- **Monitor:** The old steel piping is subject to corrosion on the interior of the pipe. As corrosion builds up, the inside diameter of the pipe becomes constricted, resulting in a loss of water pressure. This piping is typically replaced when the loss of pressure can no longer be tolerated.
